UI Bulletin #106c

Subject: **Fuel Cap Tether Strap**

Models: Chevrolet Express/GMC Savana Cutaways with a service body installed

Date: December 13, 2012

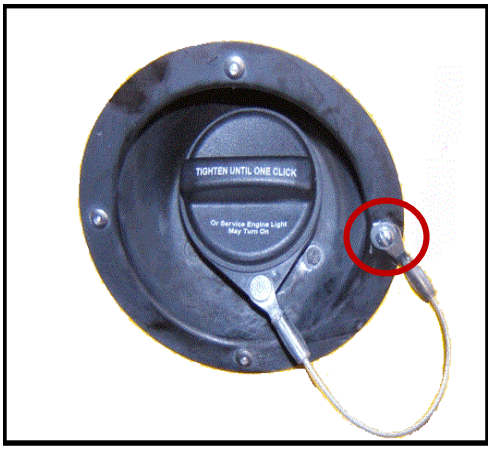
This

A condition may be caused by the fuel cap tether binding when installing the fuel cap and not allowing the fuel cap to seal completely or by the fuel cap tether being trapped between the fuel cap seal and the fuel fill pipe, not allowing the fuel cap to seal completely, possibly resulting in a Service Engine Soon Light being illuminated.

To avoid the above noted condition, all vehicles with a service body installed and using a stainless steel tethered fuel cap (9B4) should tether the cap as shown below.
